TIGER GROUP, INC.

Home Inspection Report

122 East Rd, Building 1
Local town, CT

Date: October 1, 2014

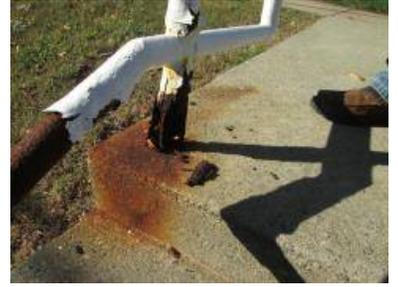
Photo #1:

Rust-damaged railing at exterior steps.

Recommend repair to the rusted entry railings.

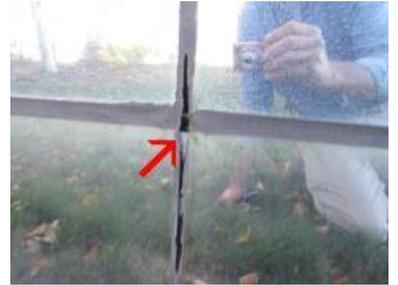
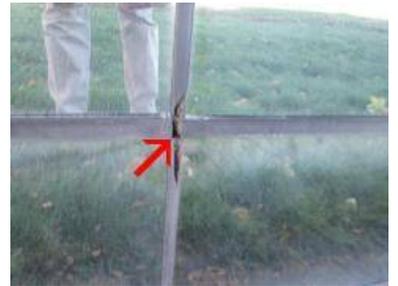
Photo #2:

Damaged/failed sealant at glass panels.

Exterior cladding is composed of Thermopane brand glass panels. There is one broken panel at the lower east side of the structure that should be replaced. Multiple areas of the sealing material between the panes has failed, in particular at the lower panels and on the west side. Recommend replacement of the sealant as needed throughout the exterior.

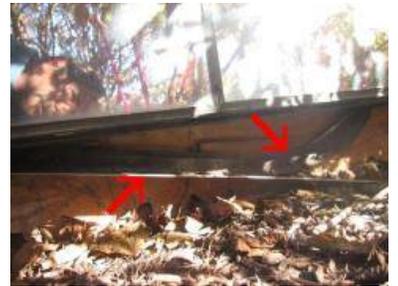
Photo #3:

Damaged exterior lower metal panel and loose insulation at foundation overhang.

Throughout the base of the structure there are multiple area where the metal covers at the base of the overhang are loose; insulation at these areas is damaged. Recommend repairs to maintain a weather-tight surface.

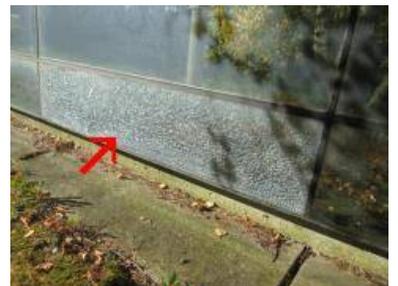
Photo #4:

Broken exterior glass panel.

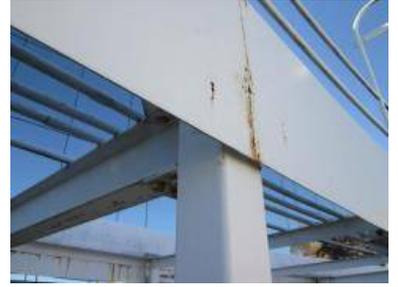
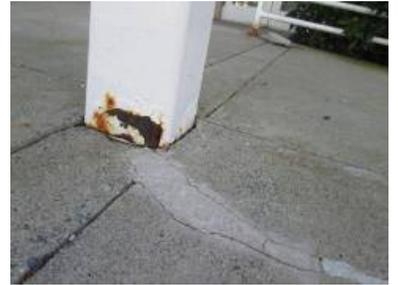
Photo #5:

Rusting at front entry canopy supports.

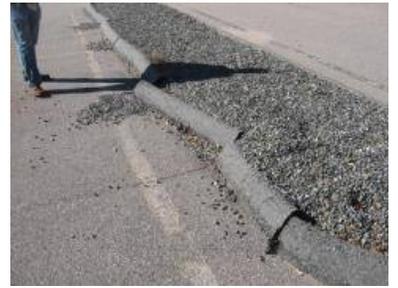
Photo #6:

The rear parking area is asphalt-paved. The paving is slightly worn with cracking in areas. Recommend sealing the cracks to extend the life of the asphalt. Striping defining drive lanes and parking stalls is significantly worn. Recommend re-striping. Drainage from the parking lot is aided by an in-ground drain. Unable to confirm the proper operation of this drain; consult maintenance personnel or the owner to determine any history of drainage concerns.

Damaged asphalt curb in back parking area. Note worn striping.

Recommend repair to the damaged curbing at the oval island. Anticipate the likelihood of ongoing plow damage during heavy snow events.

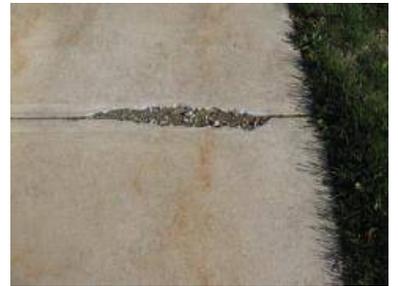
Photo #7:

Walks are concrete. Minor degradation noted at a couple of expansion joints.

Deteriorated concrete walk at expansion joint.

Recommend repairs to provide a smooth walking surface.

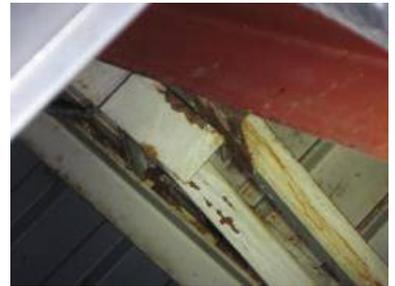
The roof structure is composed of steel beams and columns supporting open-web steel trusses. Roof decking is corrugated steel pans. Where visible, the roof framing is functional. There is a small amount of rusting at portions of the visible decking and supports; recommend cleaning and painting the affected areas. There is one section of decking that has recently been replaced along the right side near the most current roof leak. The repair appears adequate. Anticipate that additional sections of decking will require replacement during re-roofing.

Photo #1: Rust at roof trusses. Note newer roof pan at lower left.

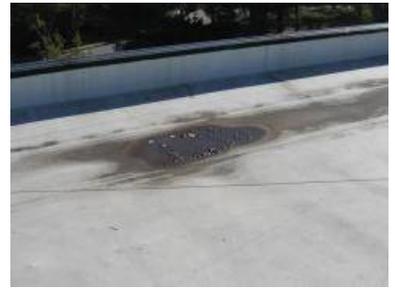
Photo #1:

Ponding noted on roof primarily at right & left sides.

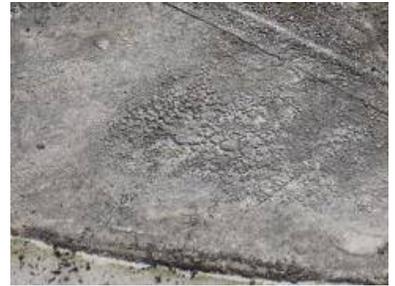
Photo #2:

Roofing consists of an ethylene propylene diene monomer (EPDM) single-ply membrane, commonly referred to as "rubber roofing." The exact age of the membrane could not be determined, but it is older and likely near the end of its expected useful life of approximately 20 to 25 years, depending on exposure and maintenance. The membrane has been patched in numerous places and coated with a fibroid paint, likely in an effort to extend its life. Some patches are of questionable quality and others are failing. Numerous areas are soft to walk on, indicating damage to the insulation or recovery board beneath the membrane; much of this damage is likely due to water penetration beneath the membrane. Several 2nd floor ceiling tiles display leak stains, indicating recent leakage. In particular, leaking along the right edge appears to have been significant. Although all accessible stained areas tested as dry during the inspection, it is probable that some stains represent active leaks. There are numerous protrusions from beneath the membrane, putting undue pressure on the membrane itself; these will cause tears and leaks in the membrane in the near future. Ponding was noted at areas of the roof, in particular at the right and left sides. This is due to uneven settlement of the roof framing or possibly compression of the recovery board/insulation beneath the membrane. Excessive wear was noted beneath some traffic pads. Based on the apparent age of the membrane, its lack of reliability and its condition, reroofing is recommended. The existing membrane should be removed to inspect and repair any damaged recovery board/insulation and to better evaluate the corrugated steel decking for any significant rusting. It may be possible to postpone reroofing for a couple of years through immediate repairs and ongoing patching, but the cost of repairs/maintenance will increase over time. Recommend further evaluation by a roofer to obtain repair & maintenance costs vs replacement costs.

Worn roofing at back left corner.

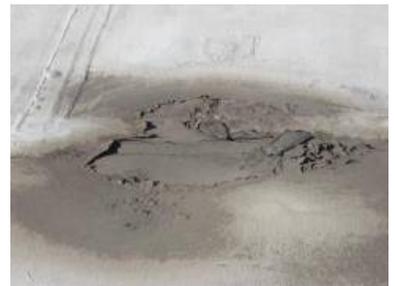
Photo #3:

Failing roof membrane top-coat sealant.

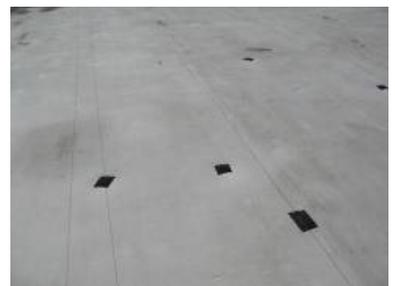
Photo #4:

Numerous patches of questionable durability.

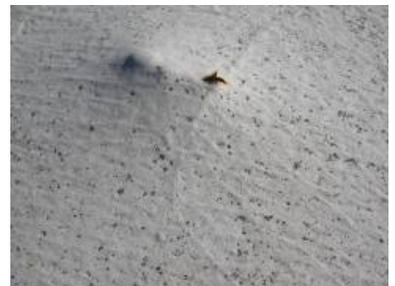
Photo #5:

Protrusions beneath roof membrane are breaking through. Patching will be needed as ongoing maintenance.

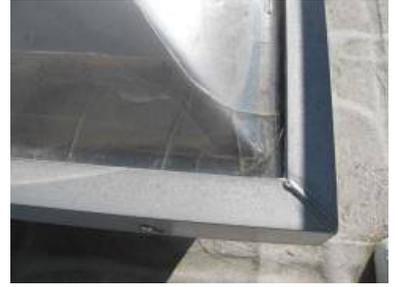
The single skylight outer plexiglass panel is cracked and is failing. Recommend replacement to help prevent leaks. Consider replacement with "fall-guard" glass or plastic as a safety precaution. The A.C. mount is steel in overall functional condition. Recommend cleaning the rust and painting to help extend its useful life.

Photo #6: Cracked skylight panel.

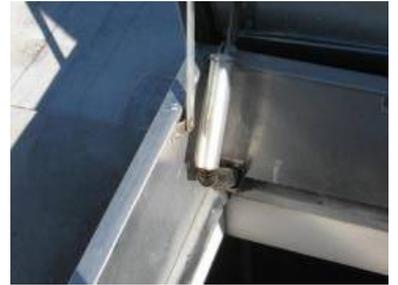
Photo #7: Damaged roof scuttle hinge.

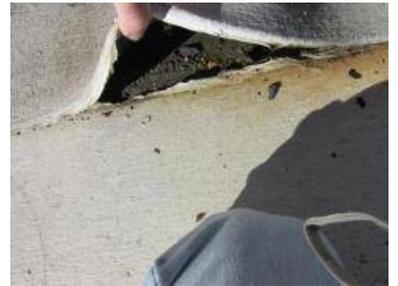
Photo #8: Worn roof membrane beneath traffic pads.

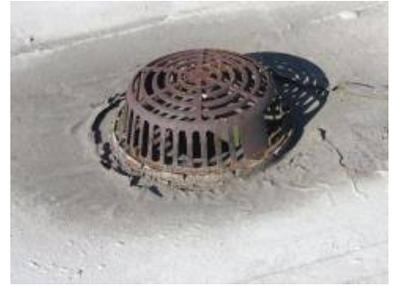
Photo #9: Roof internal drain overview. Note failing top-coat sealant.

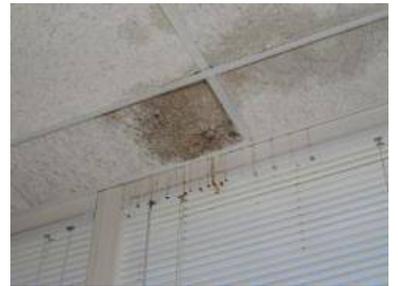
Photo #10: Example of roof leak evidence - right side.

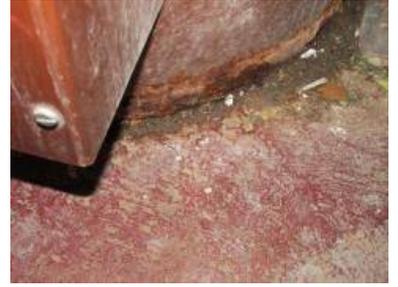
Photo #2:

Leaking, rusted water heater at first floor.

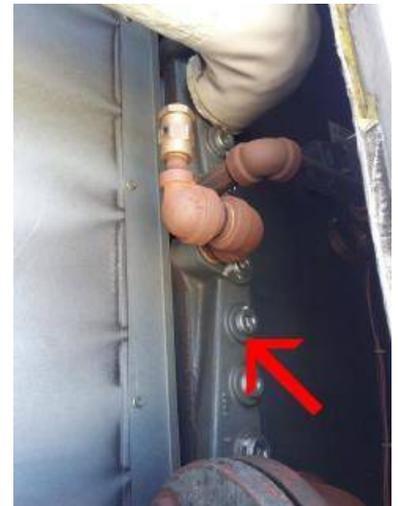
Photo #2:

Unit #2: recently replaced heat exchanger.

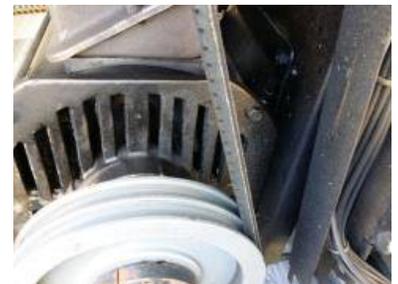
Photo #3:

Unit #1 & 2: recently replaced compressors.

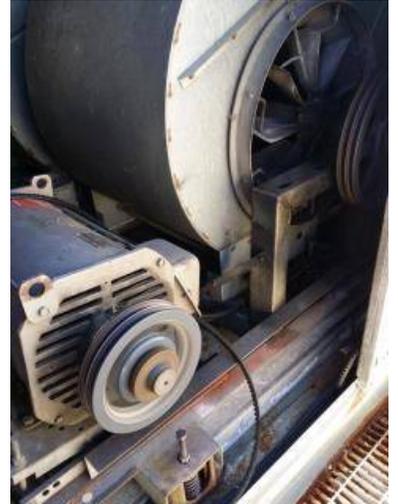
Photo #4:

Unit #1 broken fan belt.

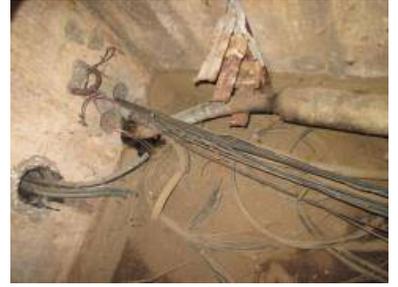
Photo #6: Abandoned wiring in sump.

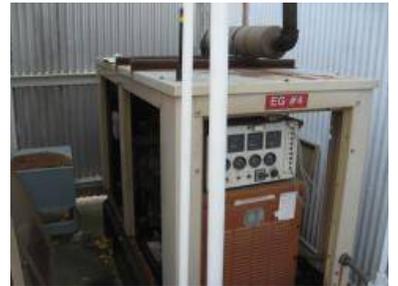
A small generator has been installed at the exterior behind the small building housing the ATM machine. Model # 94A02822-S. Serial # 2013585. 120/208 volt, 3-phase, 86.7 amp max. output. It is not clear that this generator conveys with the property. Recommend consulting the owner to determine its status. The generator was being repaired during the inspection and its suitability for use & reliability could not be determined. The evaluation of generators is beyond the scope of this inspection.

Photo #8: Non-functional small generator behind ATM building.

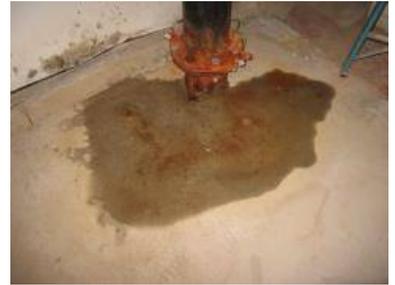
There is a fire sprinkler system installed. It appears to be a wet, full-coverage system but this could not be confirmed. The system incorporates an exterior shut-off valve and one exterior siamese connection. The sprinkler system is not inspected or tested as a part of this inspection. Suggest confirmation of yearly service by specialist, if none available, have the system inspected by service company. The sprinkler system main valving is located in a room separately-accessed to the left of the front main entry. One valve is currently leaking and repair is recommended.

Photo #2: Leak at one valve of sprinkler main valving.

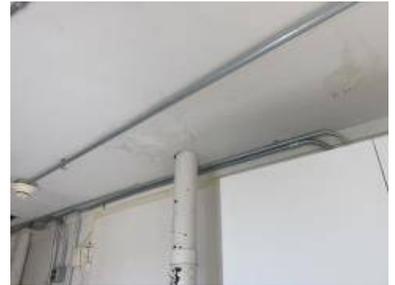
Photo 3:

Security building: water stains at ceiling.

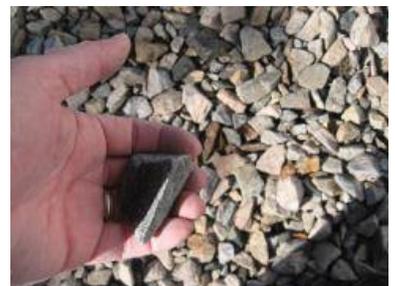
Photo 5:

The roof membrane was largely covered with ballast and not visible. The visible portion was patched in several areas, indicating wear and limited reliability. Recommend further evaluation to determine the need for replacement. The ballast has numerous sharp-edged stones in it; these may damage the membrane. Recommend replacement of the ballast with "river rock," smooth-edged stones.

Security building: sharp-edged stones as ballast on membrane roofing.

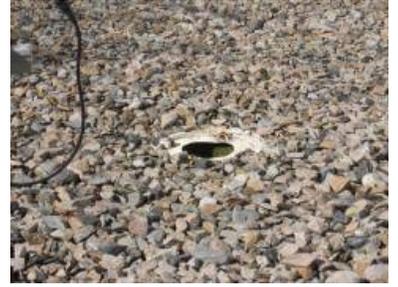
Photo 6:

Security building: missing roof drain cover.
