PROPERTY CONDITION

ASSESSMENT

PROPERTY CONDITION ASSESSMENT REPORT OF

Sample Town, CT

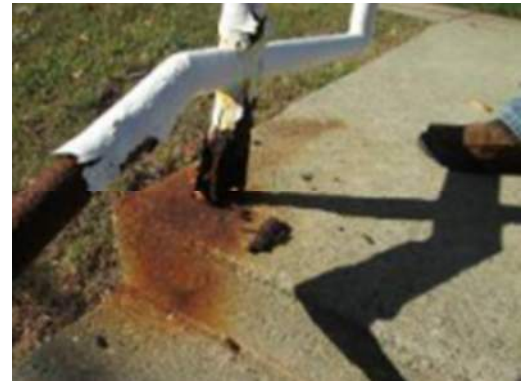
- There are landscaping beds with vegetation in good order. Cut back trees from electric service entry.
- Remove wood from soil contact at front of building to prevent negative impact of moisture and insect infestation.
- Railings are rusted and in need of repair or replacement.

Rust failing at the exterior rails

Stairs leading into the building at the entry are in serviceable condition. Railings are in need of repair or replacement.

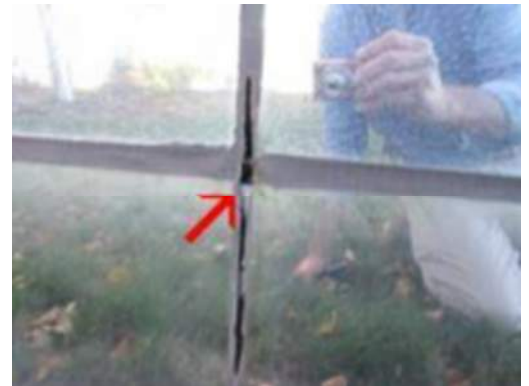
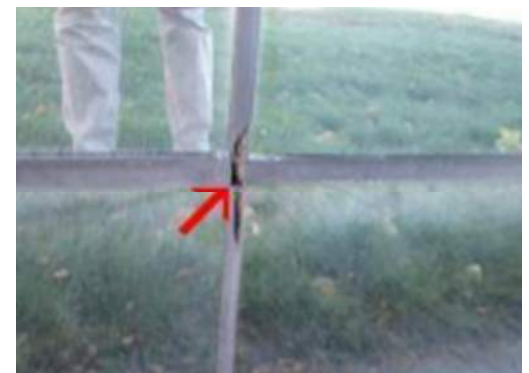
Damaged / failed sealant at glass panels.

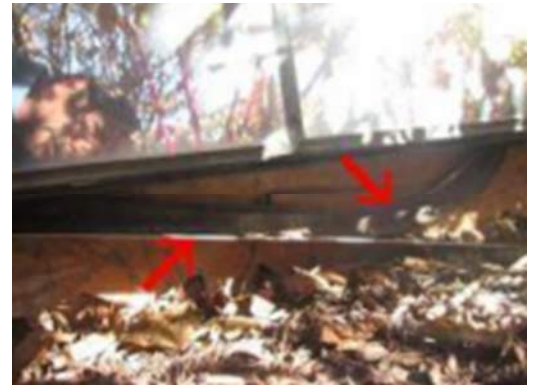
Glass and metal. Extensive repairs are needed due to damaged panels. Deteriorated panels from moisture damage, delamination, nesting, open voids.

Damaged exterior lower metal panel and loose insulation at foundation.

Multiple areas of prior patching noted. Also, consider alternative repair materials, potential application siding.

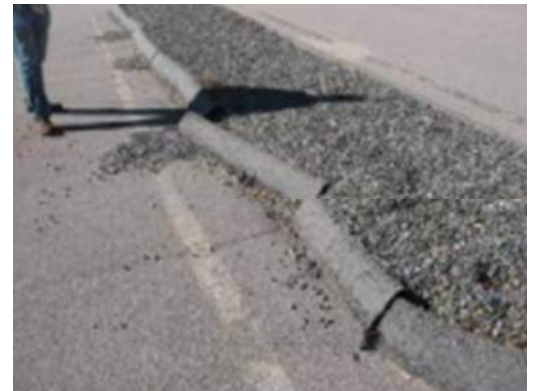
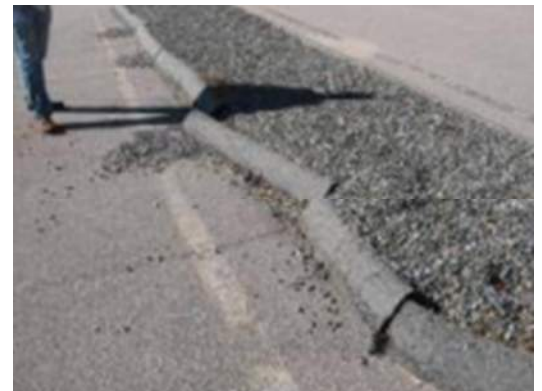
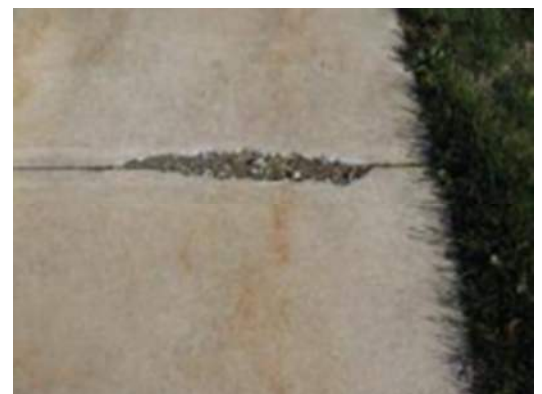
Deteriorated concrete walk at expansion joint.

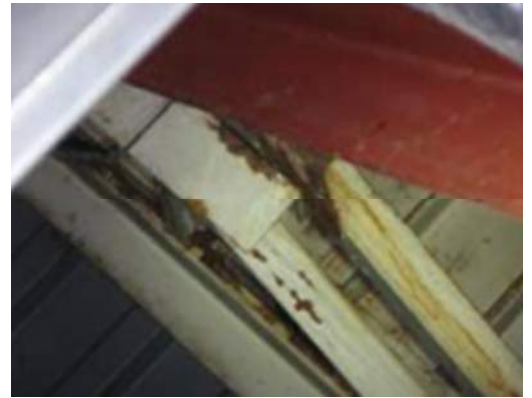
Rust at roof trusses. Note fewer roof pan at lower left., and sealing.

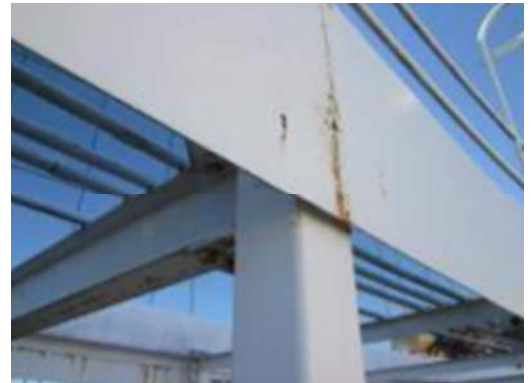
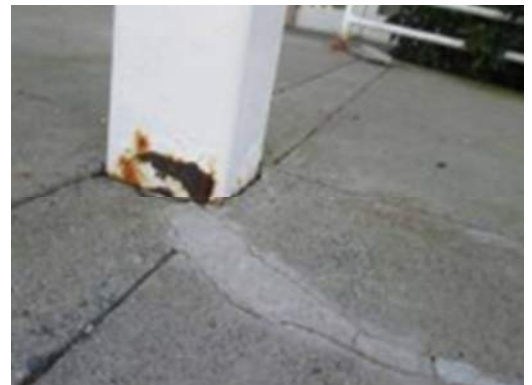
Rusting at front entry canopy supports

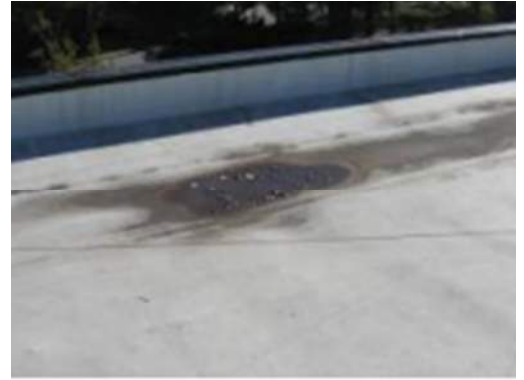
Ponding noted on the roof primarily at right and left sides.

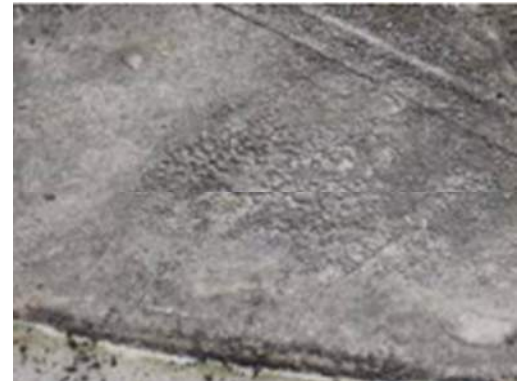
Worn roofing at back left corner

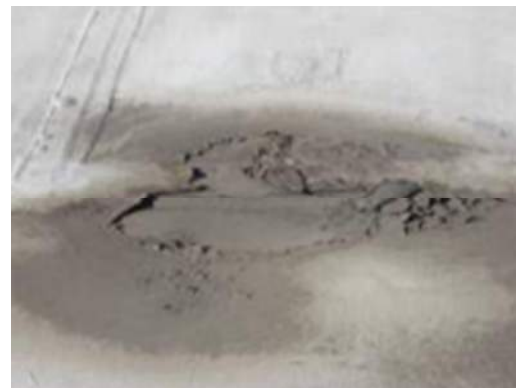
Failing roof membrane top-coat

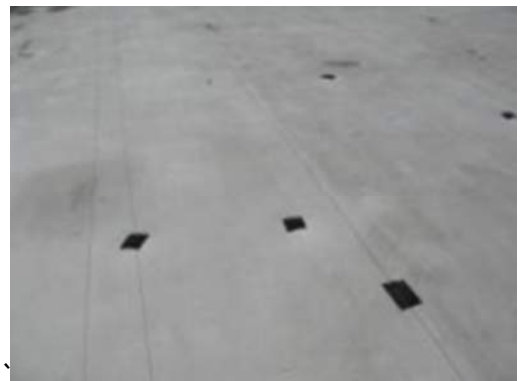
Numerous patches of questionable durability

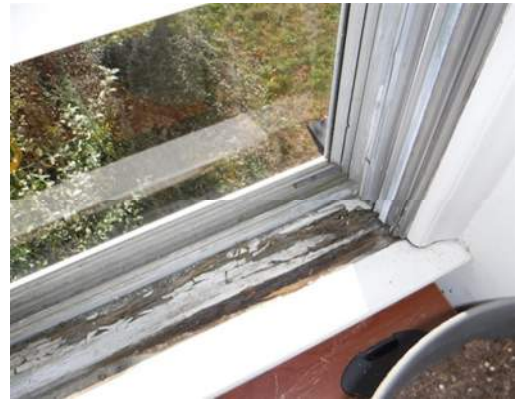
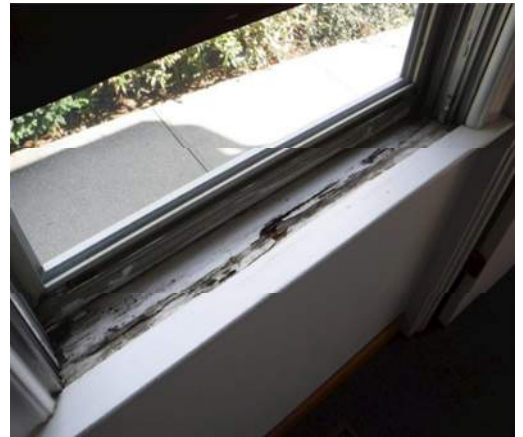
The window sills first level windows exhibit significant rot and decay. It cannot be determined if this process has been halted by the installation of the storm windows.

Window sills at the rear of the building deteriorated. Suggest repair to insure water infiltration is eliminated.

Anticipate wall damage below the sills. Suggest intrusive inspection at the sills and the portion of wall below to determine the extent of the damage not accessible to this inspection due to finished surfaces.

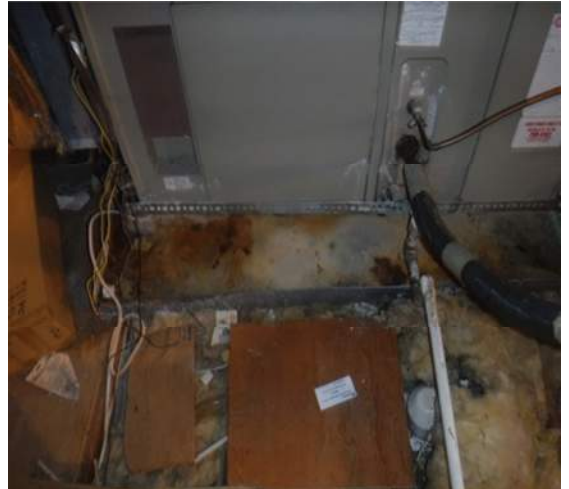
Corroded condensate pan at attic unit.

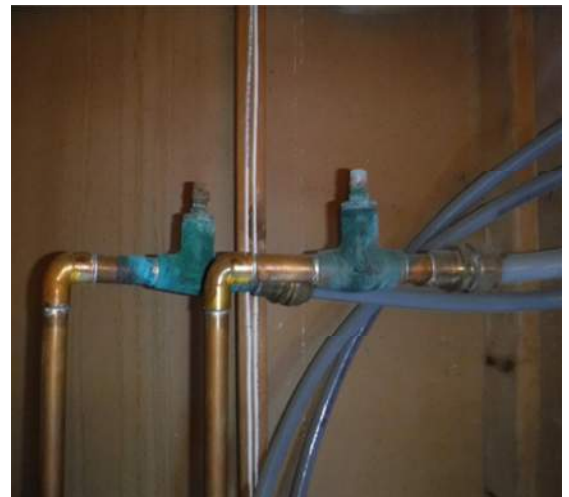
The pipe fittings at the boiler are corroded and in need of maintenance or replacement.

Corroded fittings at the boiler in the lower level mechanical room.

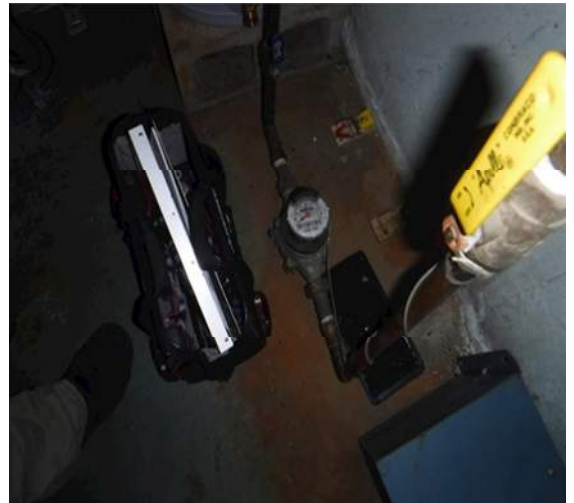
No conducting jumper at the water meter.

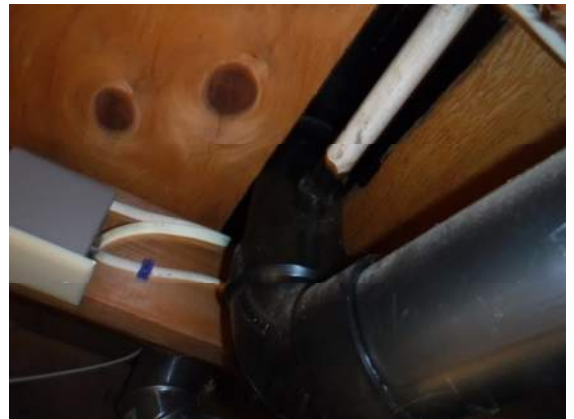
- The condensate drain above the men's bathroom is connected to the vertical waste vent piping via a "drilled hole" in the waste pipe. This connection is leaking. Recommend a qualified plumber prepare a scope of work and cost to make a proper connection.

Condensate line connection at the waste vent

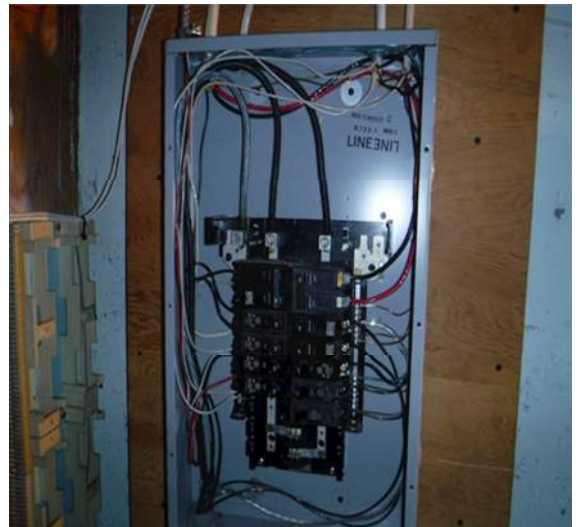
- There is a feeder/branch circuit subpanel in the mechanical room that is fed from the main distribution panel. The subpanel was inspected by removing the dead front and viewing the interior components. Issues in subpanel are: Double-tapped circuit breakers (breaker is serving branch circuit conductors in excess of manufacture's recommendation), and no ground bond to the subpanel. Suggest obtaining a scope of work and cost to bring the panel to current standards.

Overview of the subpanel in the mechanical room. No panel ground bond.

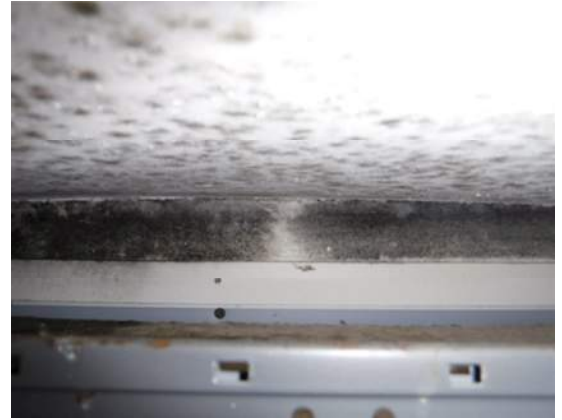
- The lower level ceiling tiles in the rear right office are water stained. The water stains appear to be caused by the buildup of condensate on uninsulated duct that distributes condition air to the office and other locations. Condensate has collected in the area on the duct, trim, drywall and ceiling tiles. The history of the leaking and condensation is a potential mold concern. Suggest testing and/or mold remediation as needed after repairs to the leak or condensate issue. The stain is not wet at the time of inspection. Suggest insulating the duct work, replacing the tiles and monitoring the duct.
- Stairs
The main stairway is original and does not meet current safety standards. Consider upgrades of baluster spacing, open risers, and railing requirements depending on the planned use.

Potential mold at the ceiling at the rear, right office in lower level.

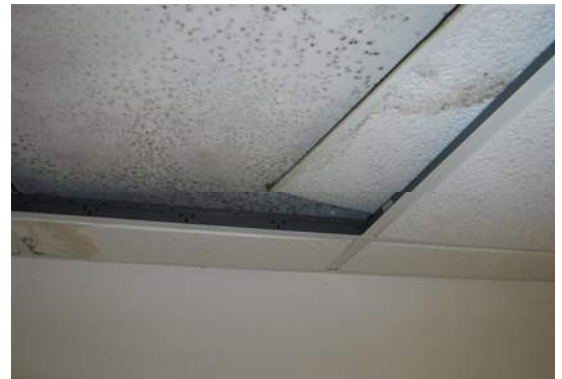
Potential mold at the ceiling at the rear, right office in lower level.

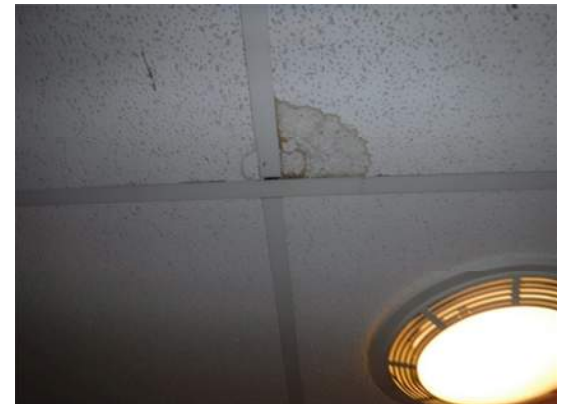
Water stain at the bathroom on first floor.

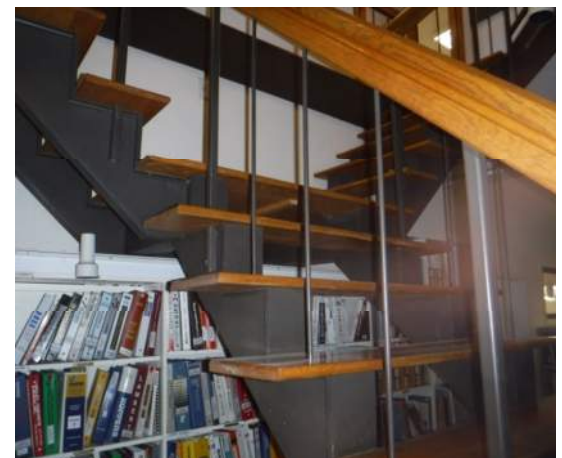
Open balusters on interior stairs.
