Mold Assessment Sample Report

123 Main Street

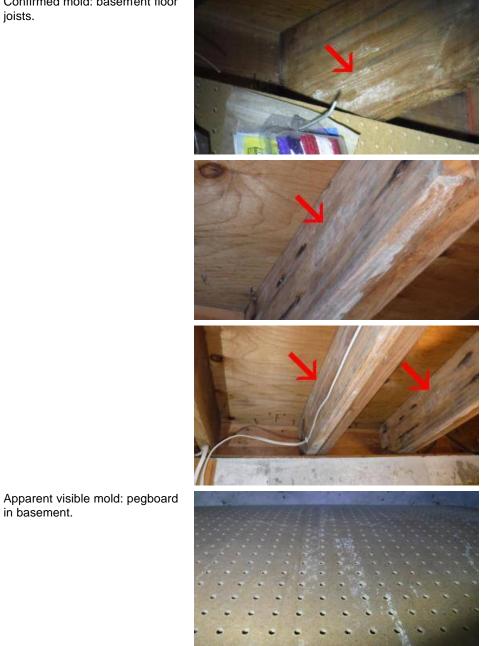
Photo #1:

Basement floor joist.

Confirmed mold: basement floor joists.

Professional mold remediation is recommended to address the following areas:
Basement.

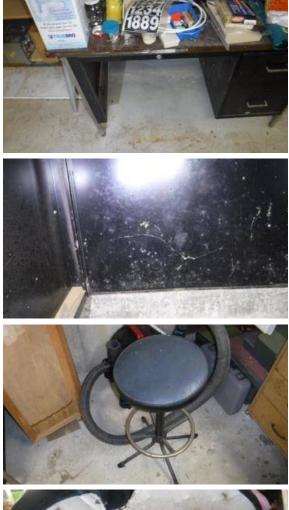
Photo #3:

Apparent visible mold: metal desk underside.

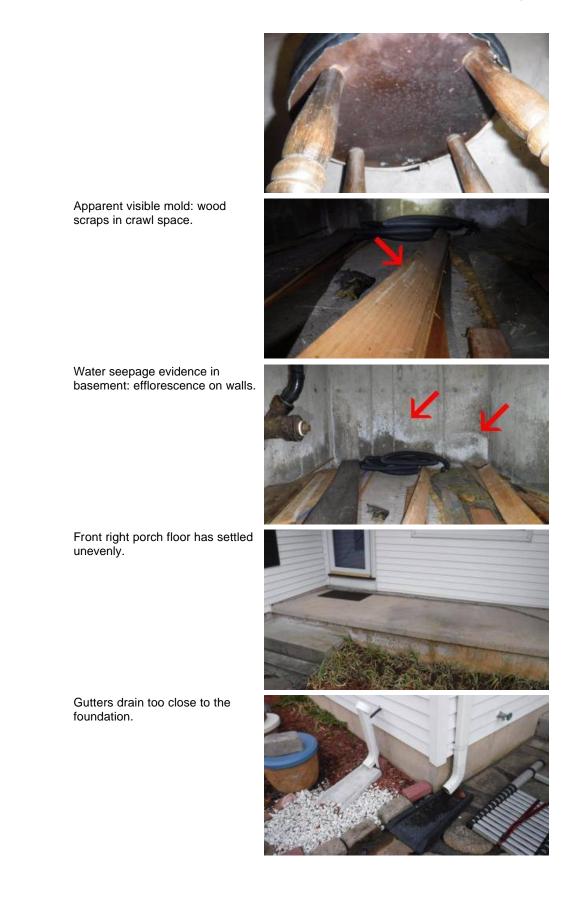
Photo #4:

Apparent visible mold: underside of two stools.

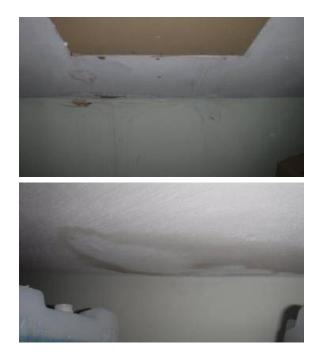
Photo #9:

Dry water stains in room over garage.
